Manhole Inspection Summary

Manhole # S31E__001MH

Inspection ☐ Is Incomplete Rating: **3) Fair**

Location Address: **118 n greene st**

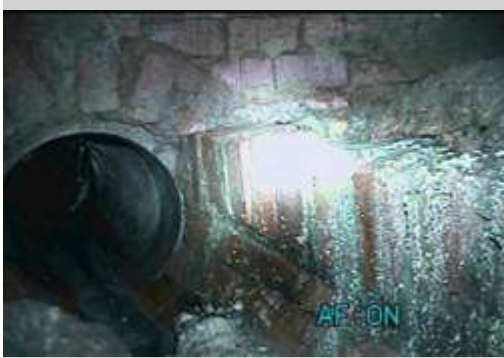
Defect 5

Condition: ☐ Sound ☐ Cracked ☐ Root Intrusion ☐ Deteriorated ☐ Leaks ☒ **Debris**

channel debris

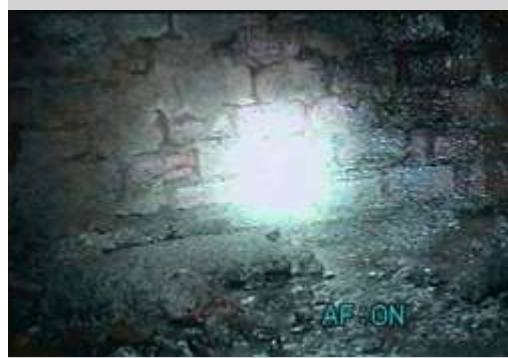
Defect 4

Condition: ☐ Sound ☐ Cracked ☐ Root Intrusion ☐ Deteriorated ☐ Leaks ☒ **Debris**

bench debris

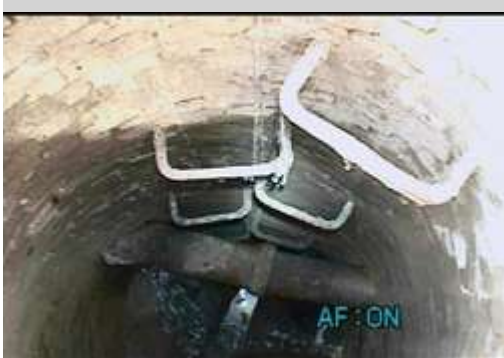
Defect 3

Count: **6** Missing: **0** ☒ **Corroded**

steps

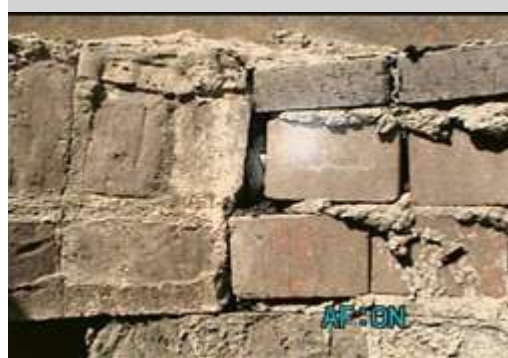
Defect 2

Condition: ☐ Sound ☒ **Cracked** ☐ Root Intrusion ☒ **Loose Brick** ☒ **Deteriorated**

loose bricks, deteriorated

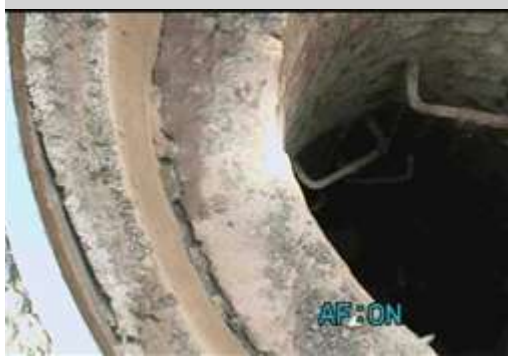
Defect 1

Offset: **4** (in.)

offset
